Cleanup at Mandirituba Power Sub Substation

Bioremediation of the Contaminated Soil

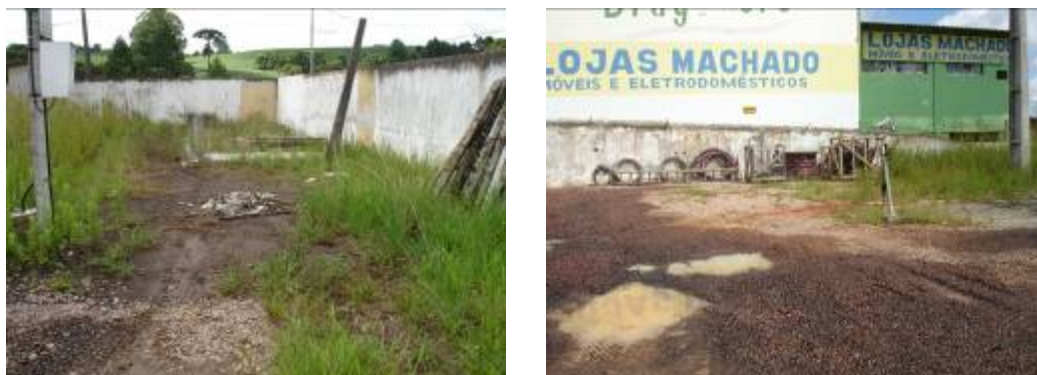
Figure 1. Mandirituba Power sub Substation

During the later parts of 2006, the Mandirituba power energy substation has many incidents of vandal attack on the unused equipment. As a result more than 15 transformers were damaged and the soil contaminated with transformer oil (Figure 1).

Analysis of the soil showed high contamination with an average TPH of 7,847 mg of transformer oil for kg of soil extending to an area of about 500 m² (5382 sq ft). Moreover, the interval of significant time between the incident and the remedial action suggested percolating of the transfer oil into deeper layers of soil likely to affect the quality of the ground water. The Table 1 shows the values of TPH at the site results.

The utility company was responsible for the cleanup suggested on-site treatment as remediation method, without transporting high volumes of contaminated soil. It was recommended to use of bioremediation for the cleanup and AgroRemed BR CTBA developed with local microbial source was considered suitable in relation to the other methods of cleanup.

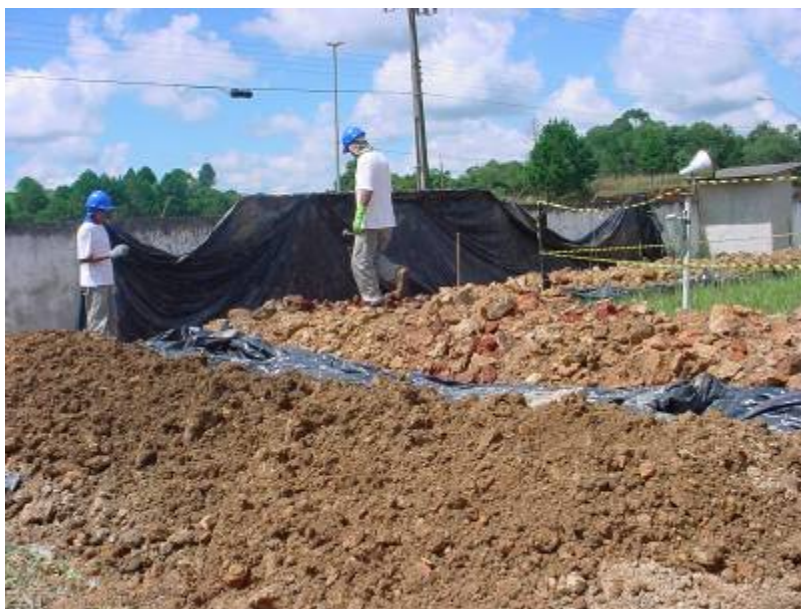
Figure 2. Stacks of treatment.

The treatment of the Mandirituba power energy substation was initiated in February 2007, after the meeting with security guard and was similar to the Municipal Grounds at the Fazenda Rio Grande work. Treatment of soil was by excavation and since the total area and the depth were greater than the one before, it was decided to divide the area in squares and treat each square one after the other. The first square was excavated and this resulted in 10 piles/stacks of soil (Figure 2). AgroRemed BR CTBA was applied on each stack uniformly after taking the samples of soil before treatment (Figure 3).
